**Flood Control Project Maintenance
Levee Inspections**

2011 Channel Summary Report

Merced Streams Group

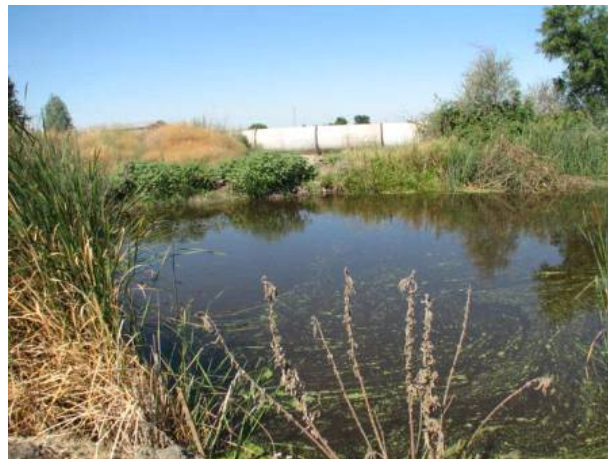
jeto_c_20110802_012.jpg

34		Up	Revetments		N	Inspector Comments: No revetments present at this location.	37.273619 ° -120.277469 °		34
35		Up	Encroachments		M	Inspector Comments: Possible excavation at this location, which appears to be impeding flow.	37.273619 ° -120.277469 °	Y	35
36		Down	Vegetation & Obstructions		A	Inspector Comments: No obstructions or vegetation noted, channel is lined at this location.	37.273619 ° -120.277469 °	Y	36
37		Down	Shoaling / Sedimentation		A	Inspector Comments: No shoaling or sedimentation present.	37.273619 ° -120.277469 °		37
38		Down	Erosion / Bank Caving		A	Inspector Comments: No visible erosion or bank caving.	37.273619 ° -120.277469 °		38
39		Down	Revetments		A	Inspector Comments: Concrete lined channel at this location, no apparent cracks or movement.	37.273619 ° -120.277469 °		39
40		Down	Encroachments		A	Inspector Comments: No trash, debris or other encroachments noted at this location.	37.273619 ° -120.277469 °		40

Levee Mile Report Line	35
Start Levee Mile	0.00
End Levee Mile	0.00
Location	
Category	Channels
Item	Encroachments

08/02/2011 Photo taken looking downstream to what appears to be material placed in the channel. Siphon is in the background.

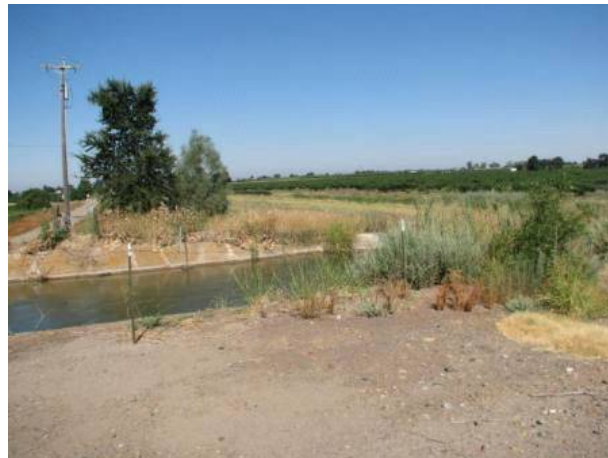
jeto_c_20110802_010.jpg

Levee Mile Report Line	36
Start Levee Mile	0.00
End Levee Mile	0.00
Location	
Category	Channels
Item	Vegetation & Obstructions

08/02/2011 Le Grand Canal, downstream view.
